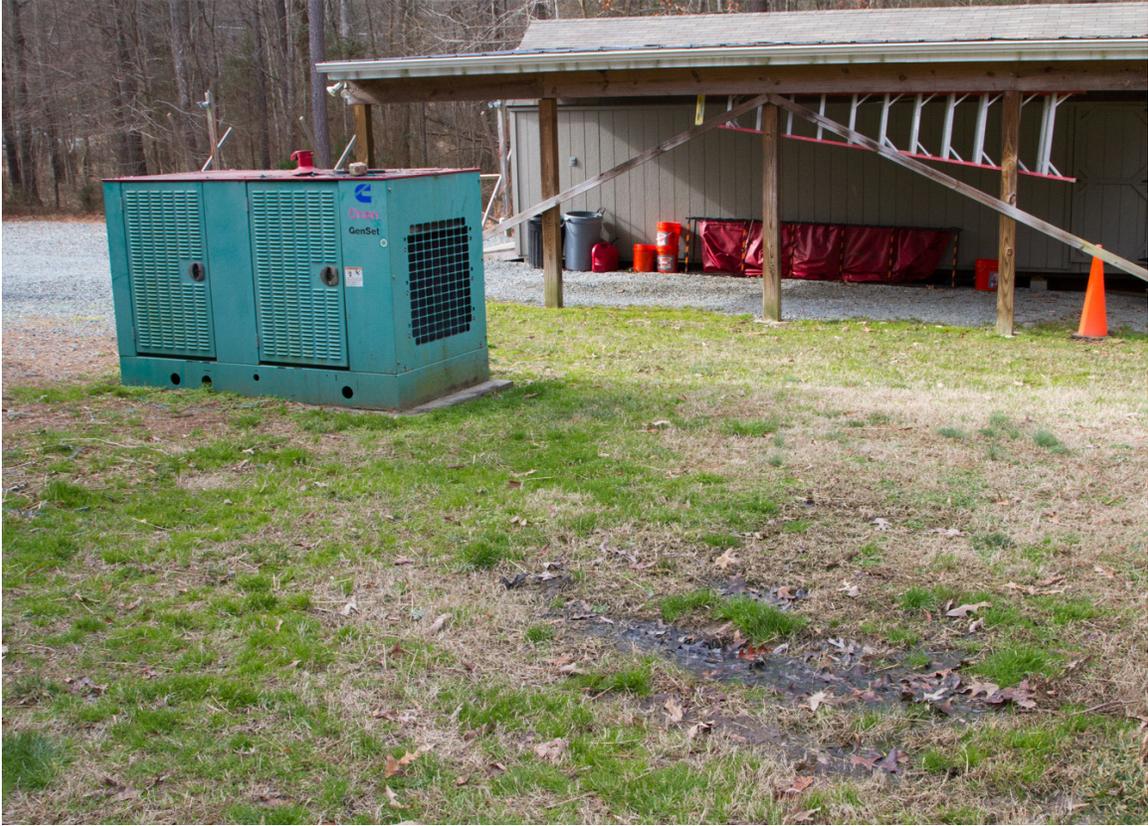
- Septic tank backing up AGAIN; due to wet weather

Wet area near generator at corner of fire station addition.

Wayland McFarland septic service - tel:919-383-1015

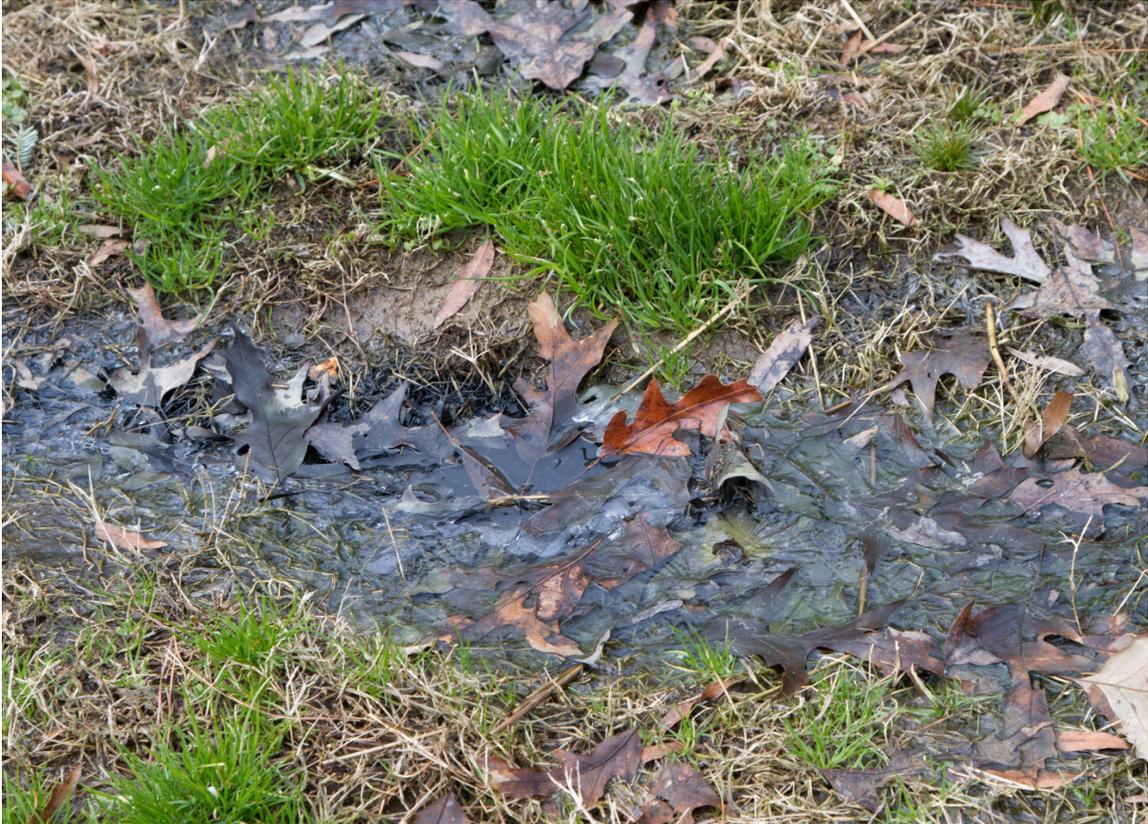
Close-up of wet spot.

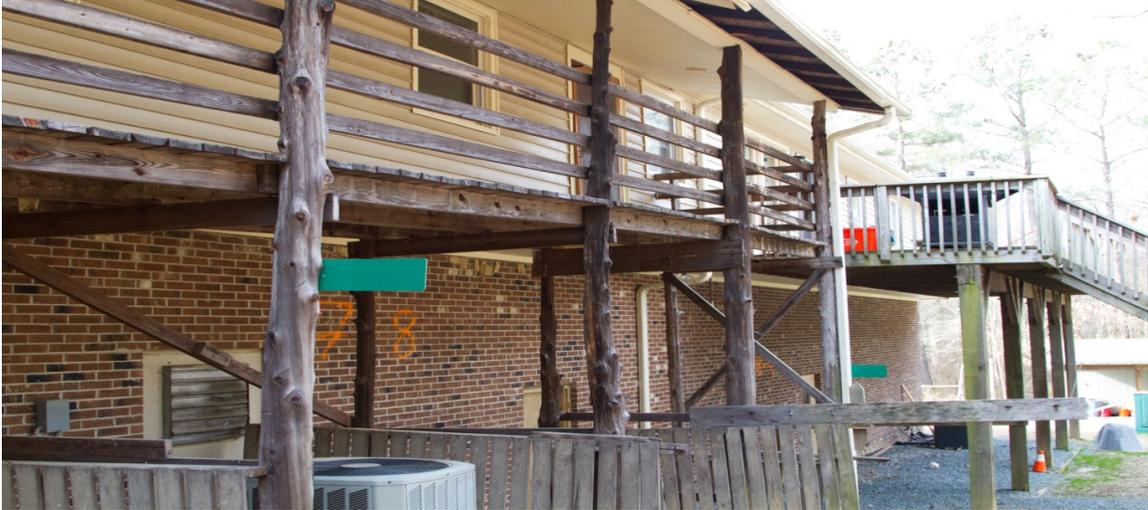
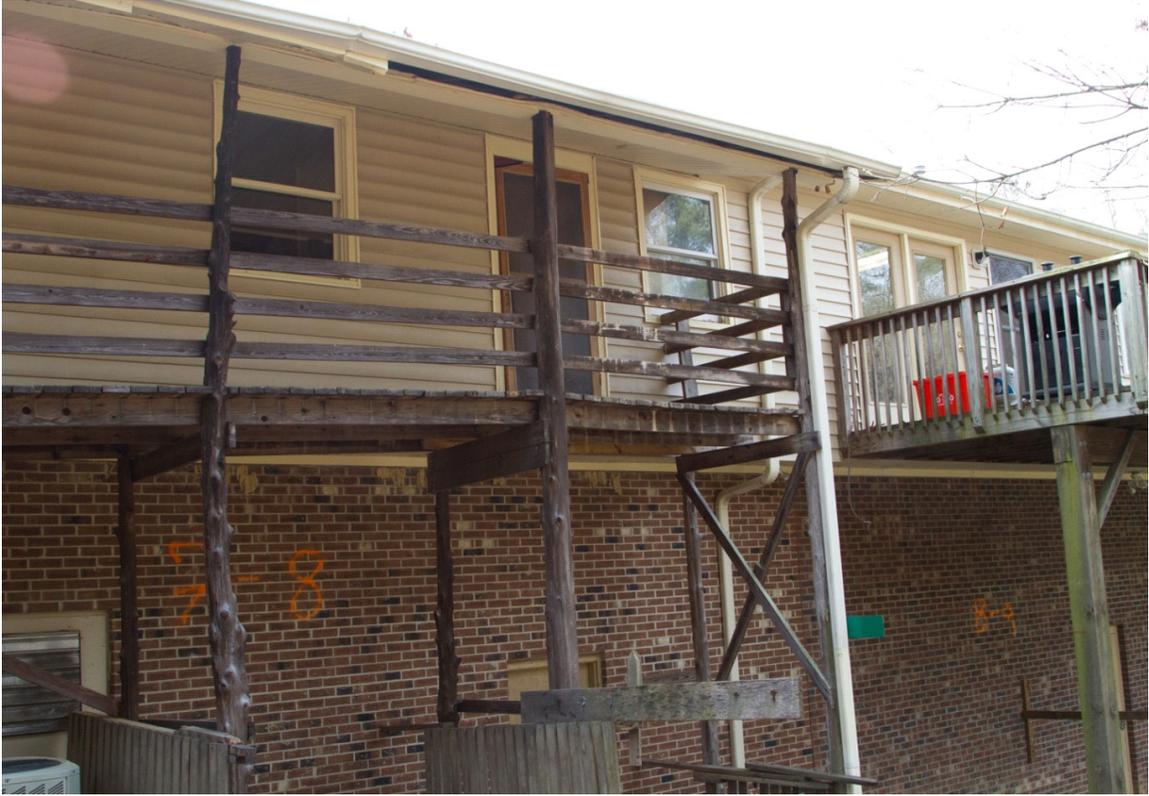
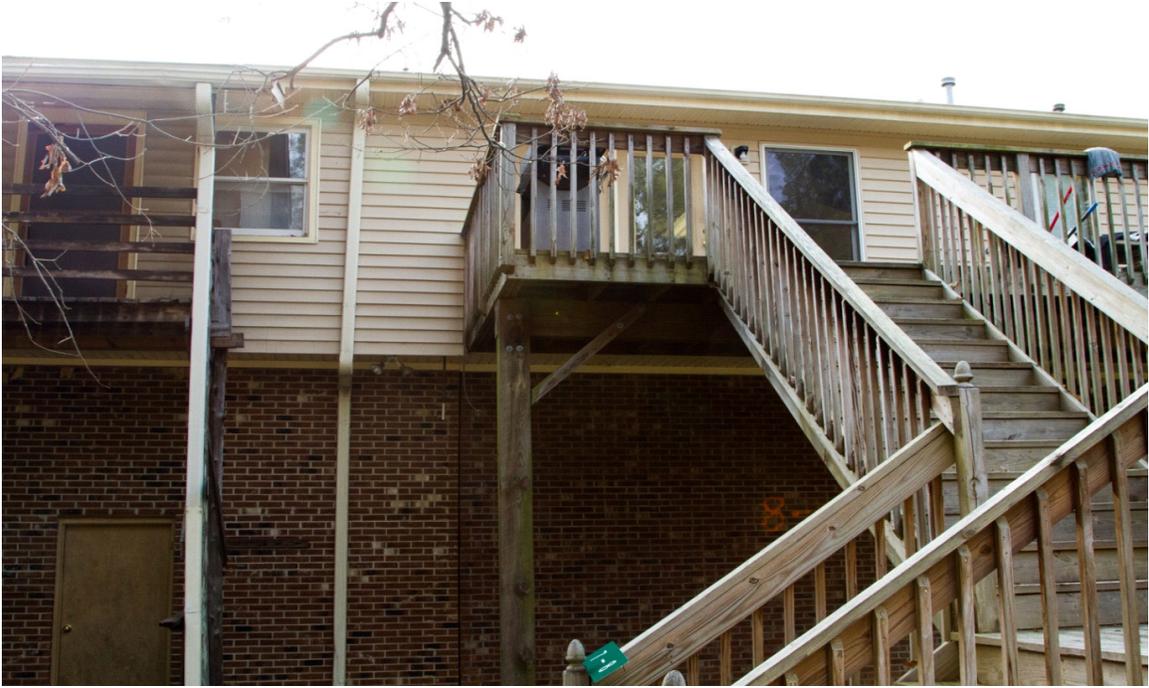
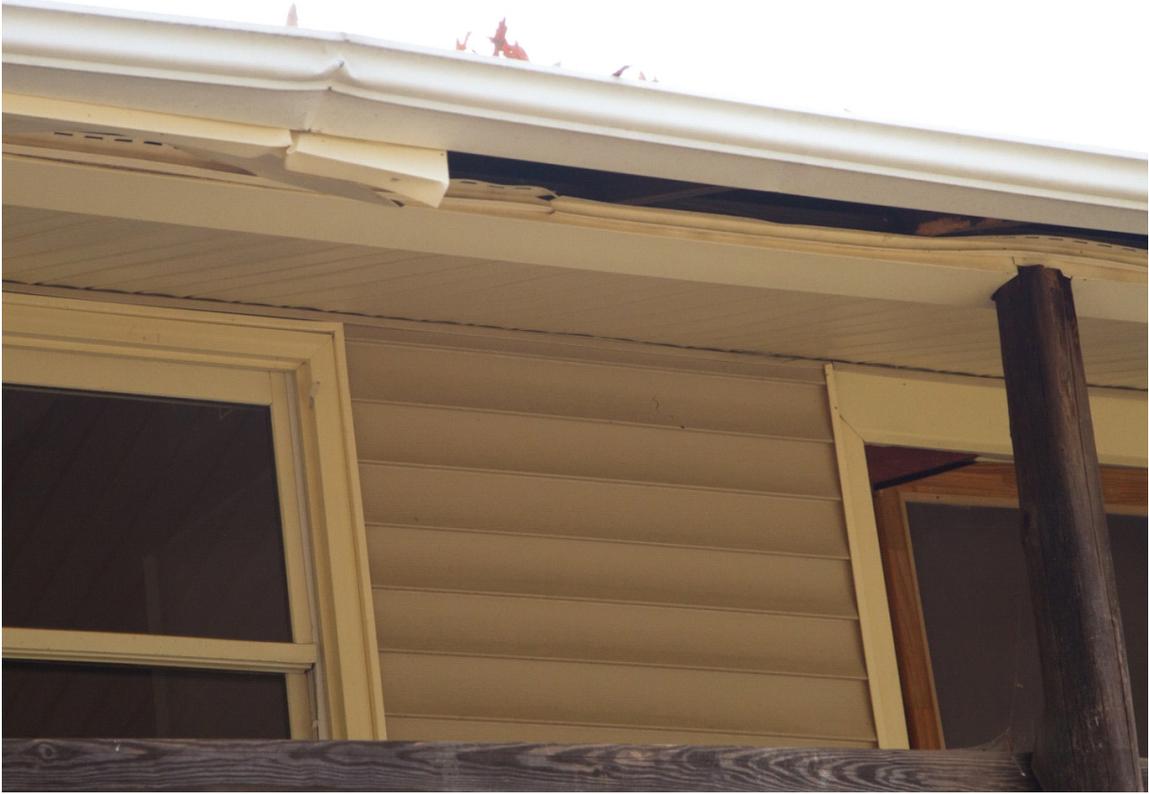
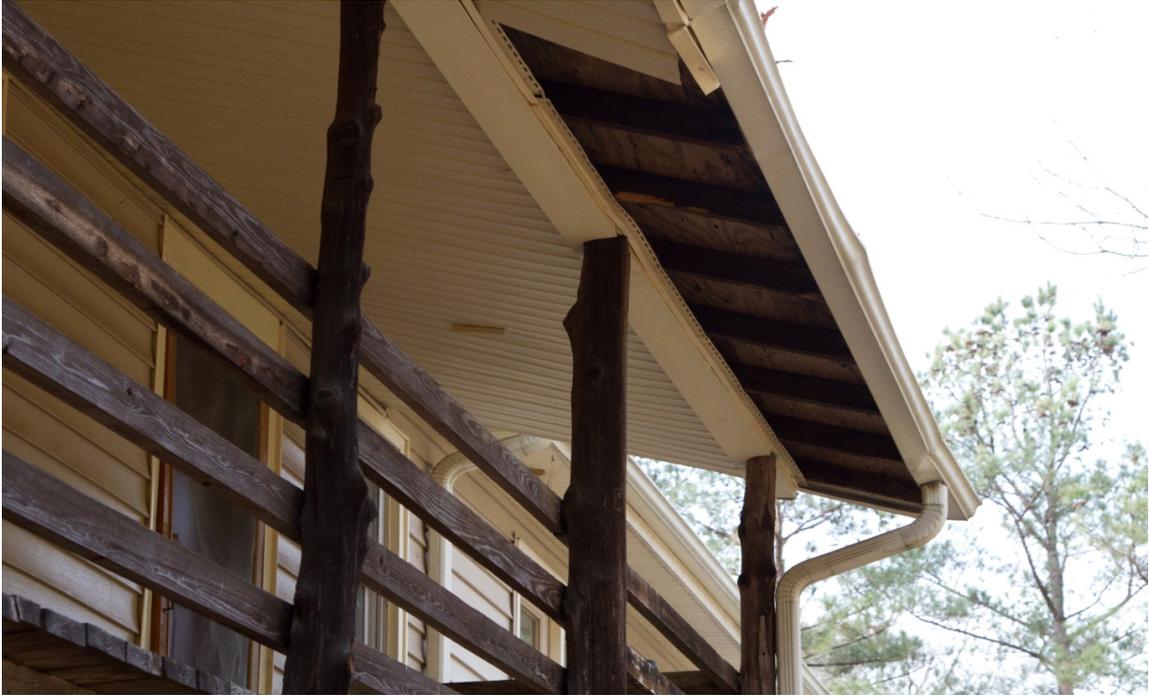
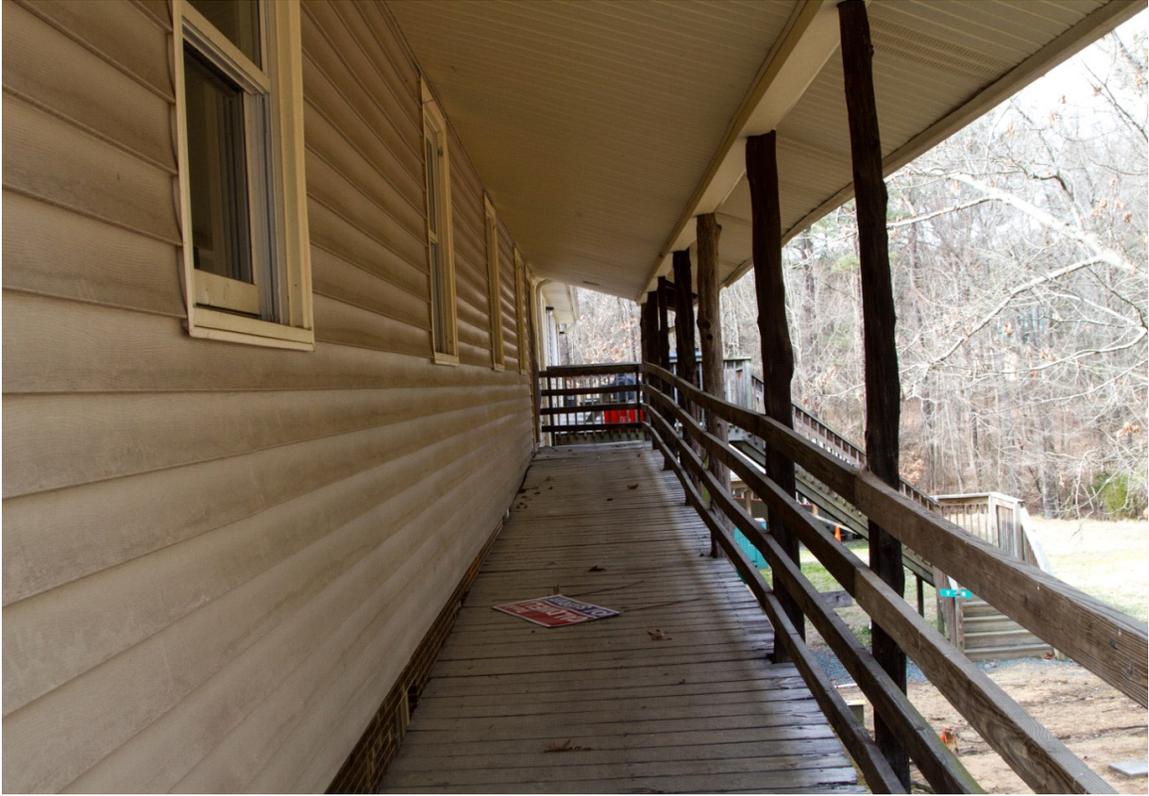
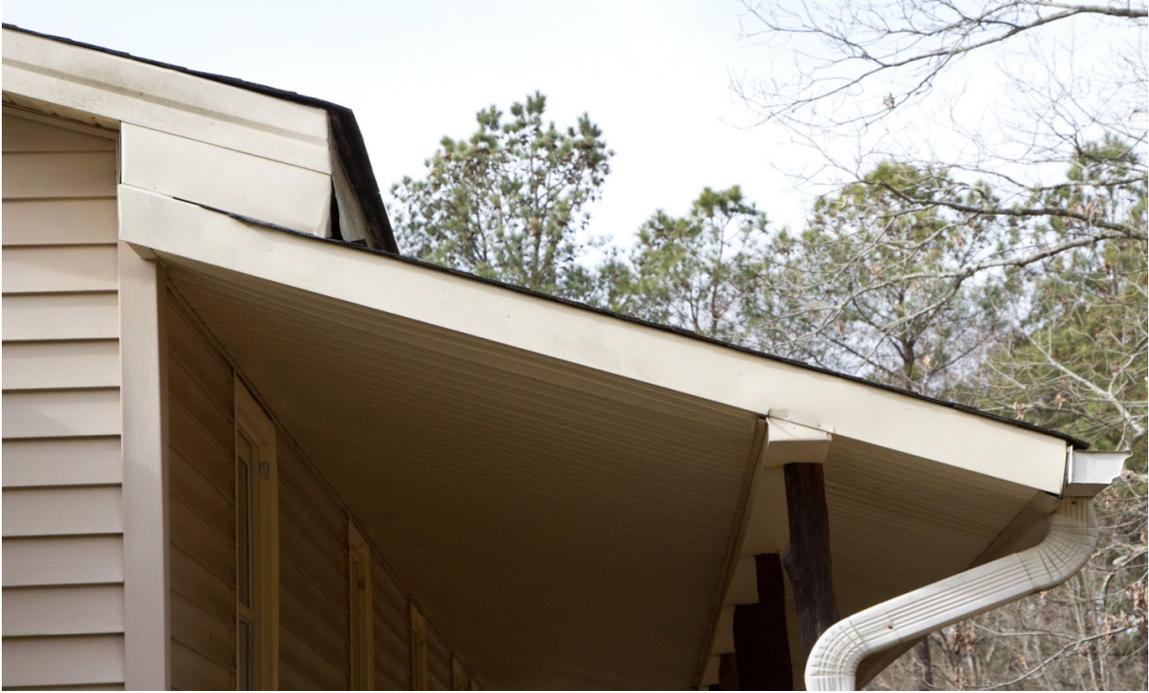
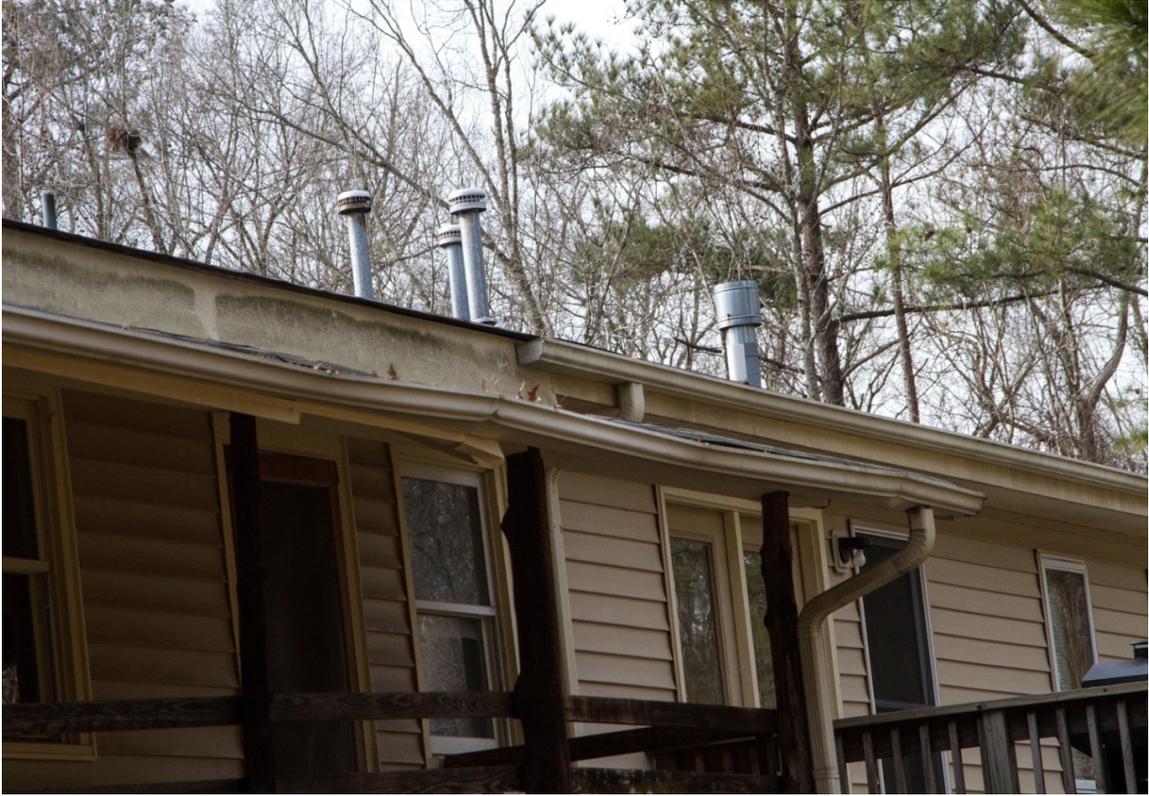
- Side Porch/Walkway/Ramp need to remove and/or replace

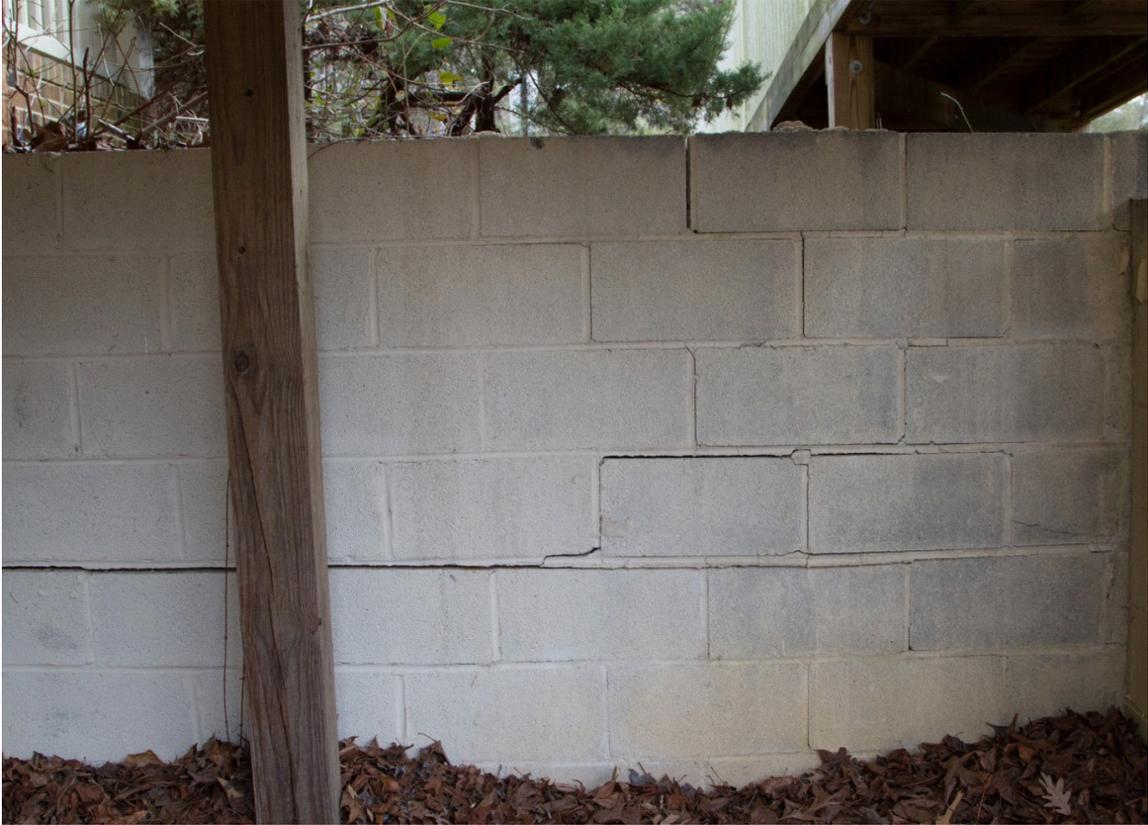
- Front Retaining wall is cracked

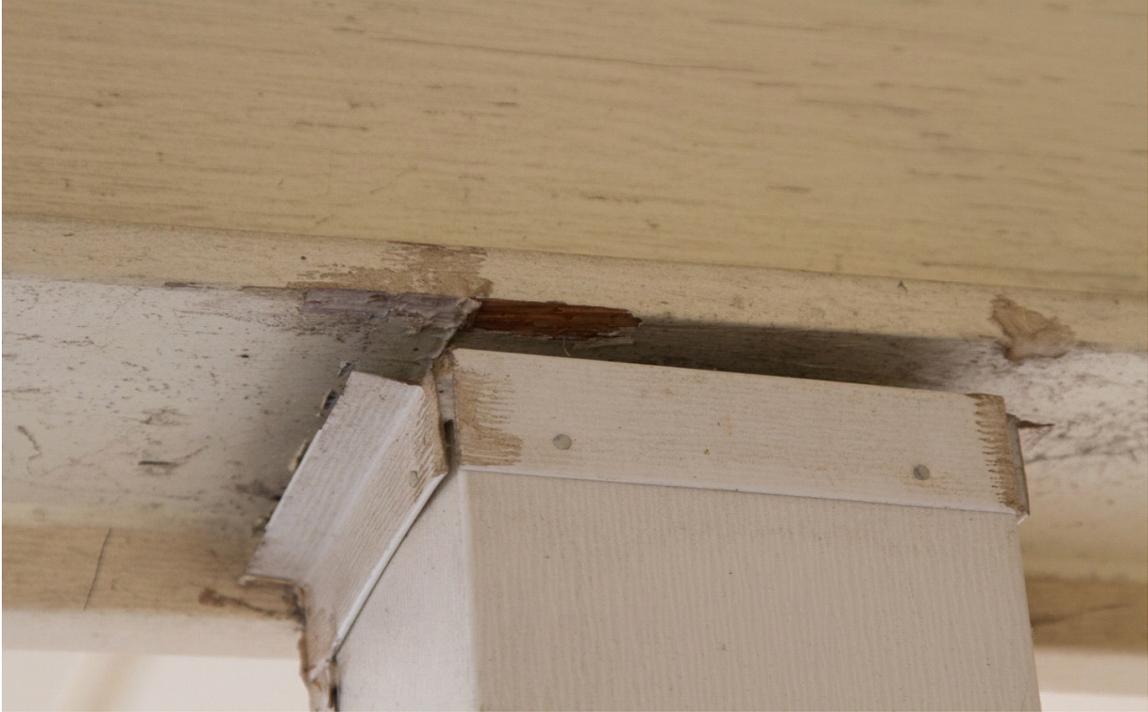
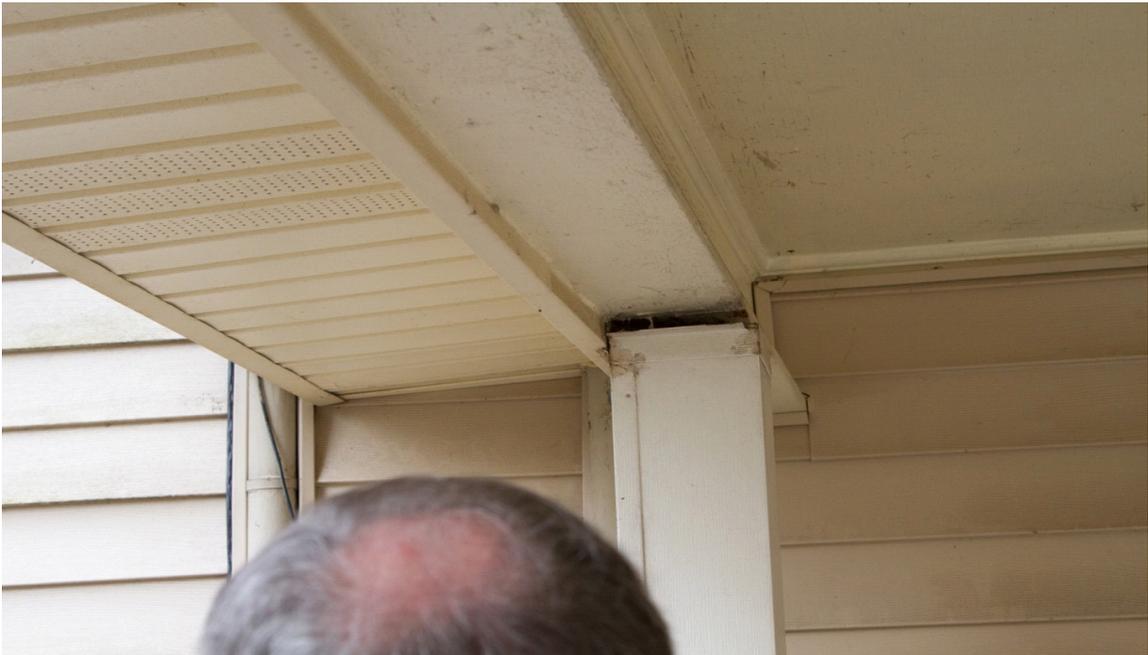
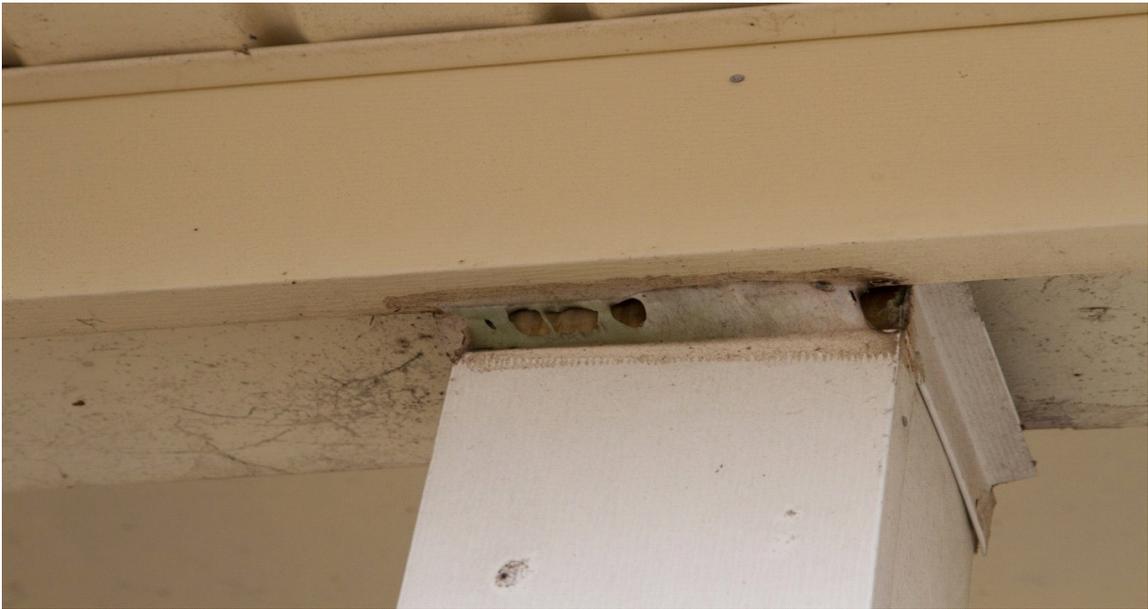
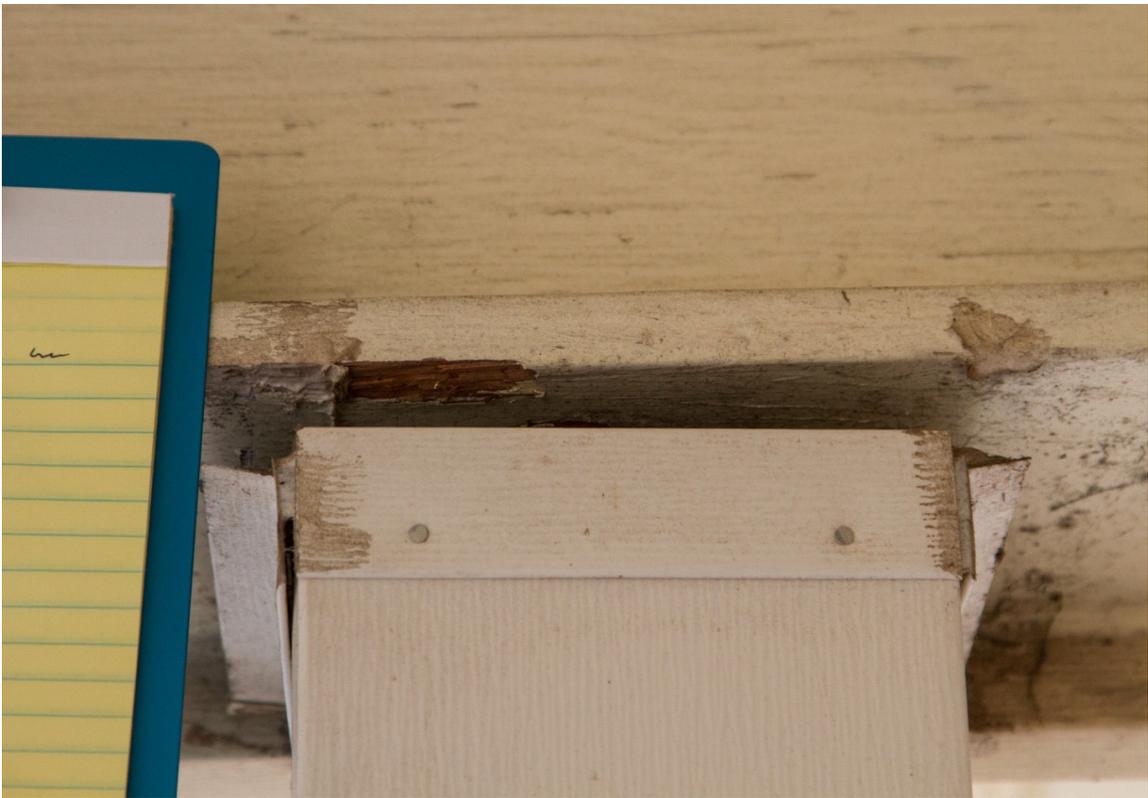
- Porch is settling and causing pillars to separate from the roof
- Front Porch Column noted to be separating from ceiling; perhaps due to settling of porch

Separation at this time is approximately 1.5 cm (or 5/8 inches). This is the column on the Whitfield Road side of the building.

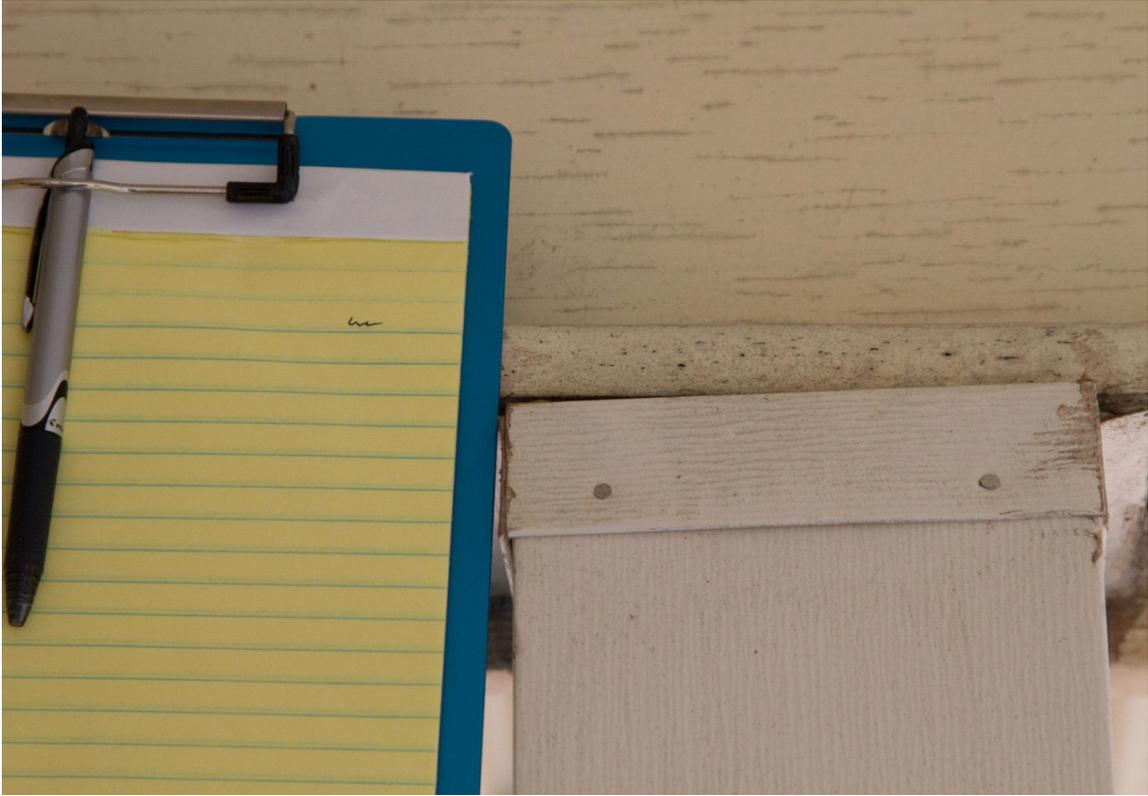
Column separation on the opposite side of the front porch. This is barely 2 cm or 1/16/ inch at this time.

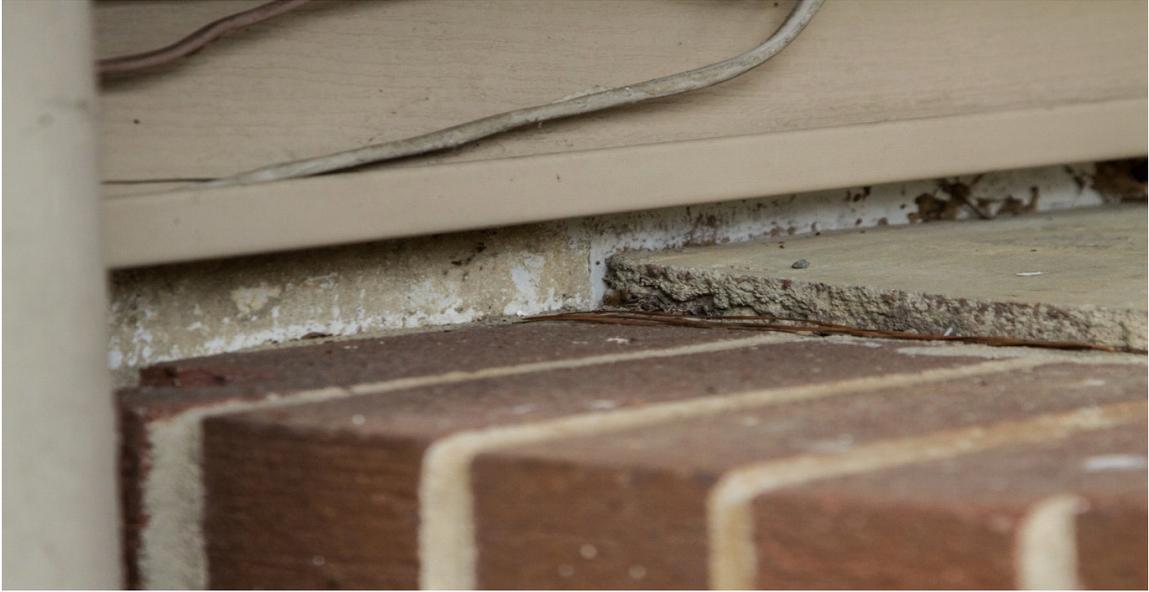
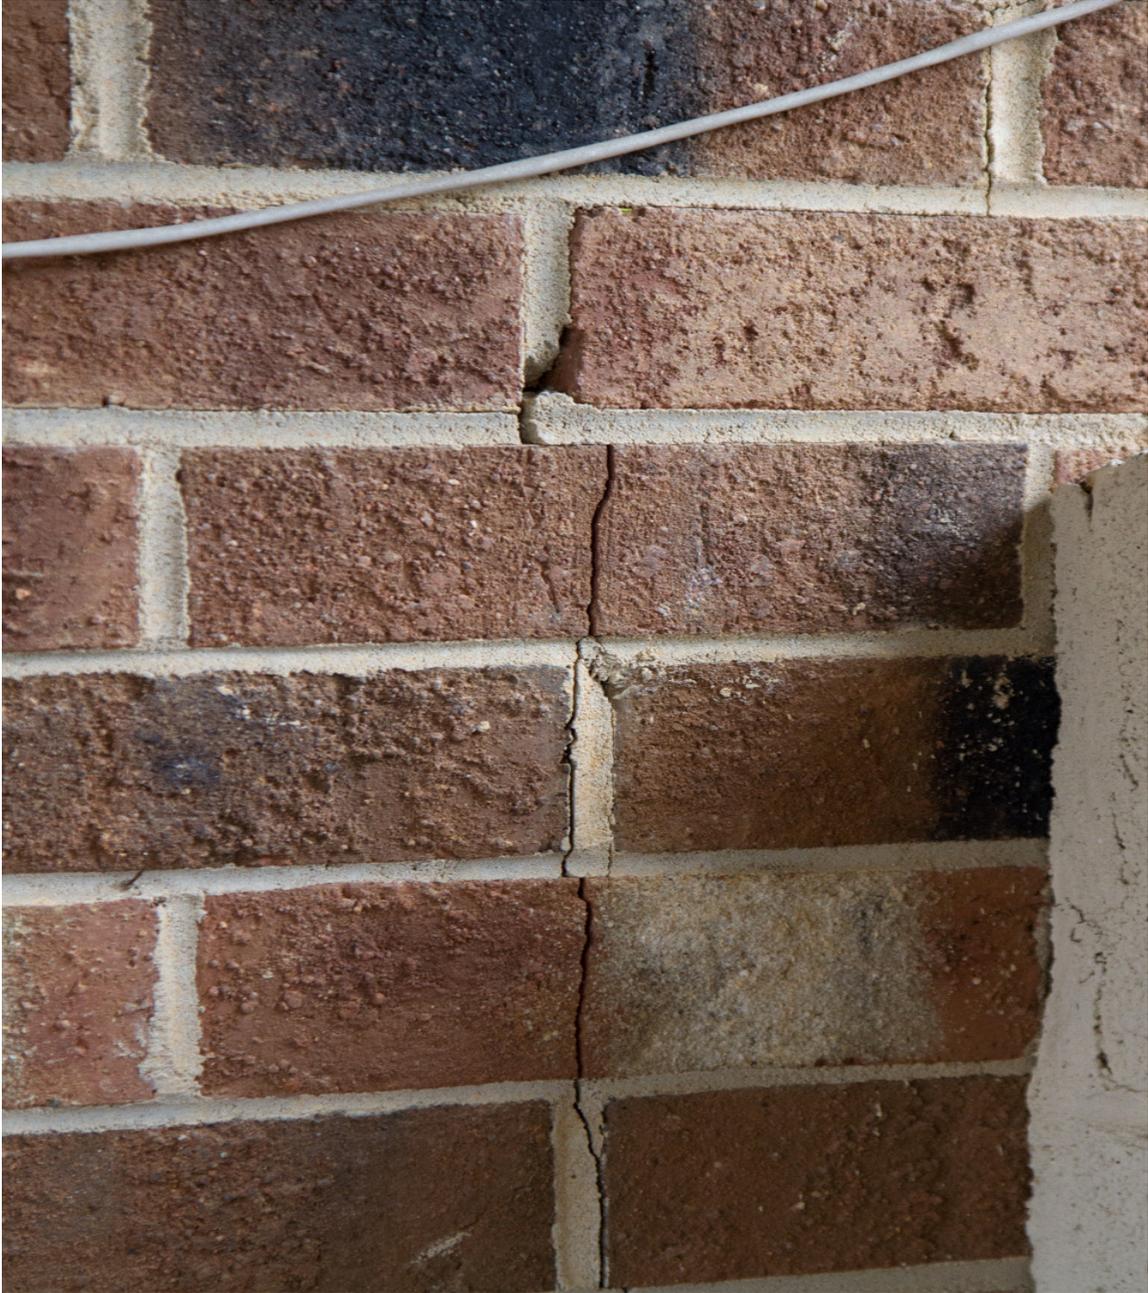
Small crack in foundation under front porch. There is very little separation of shifting visible at this time but this should be monitored.

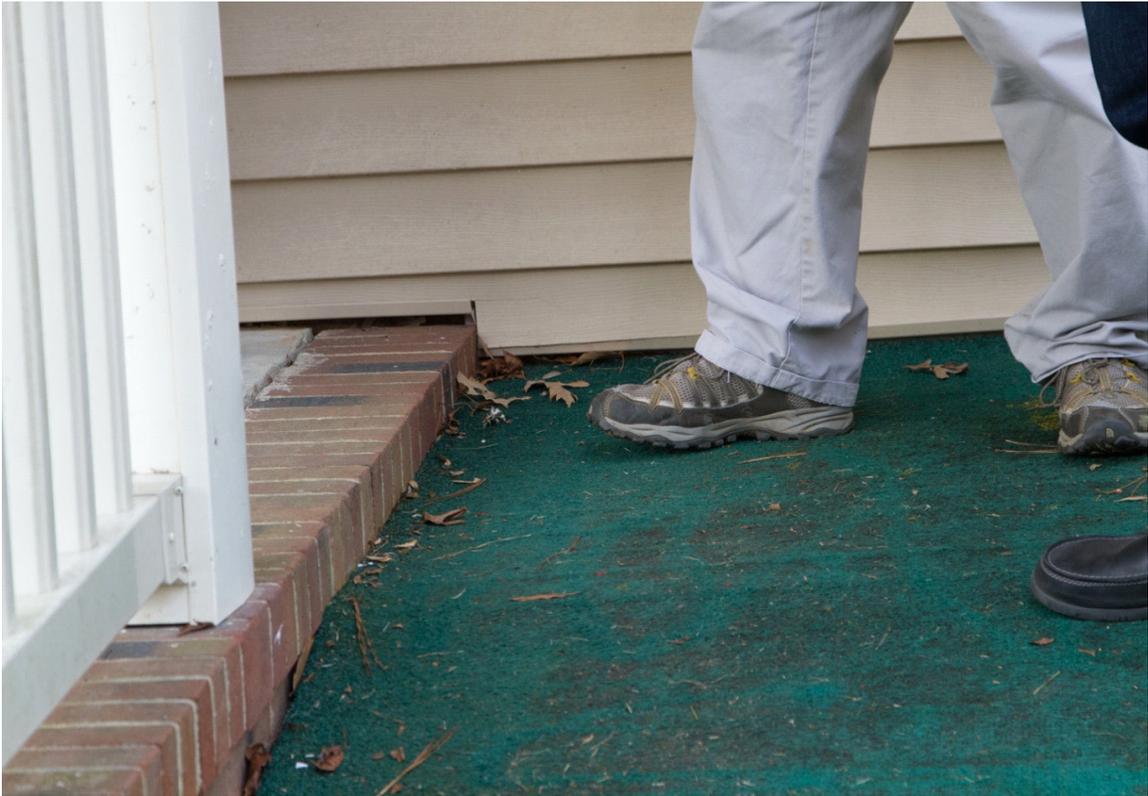
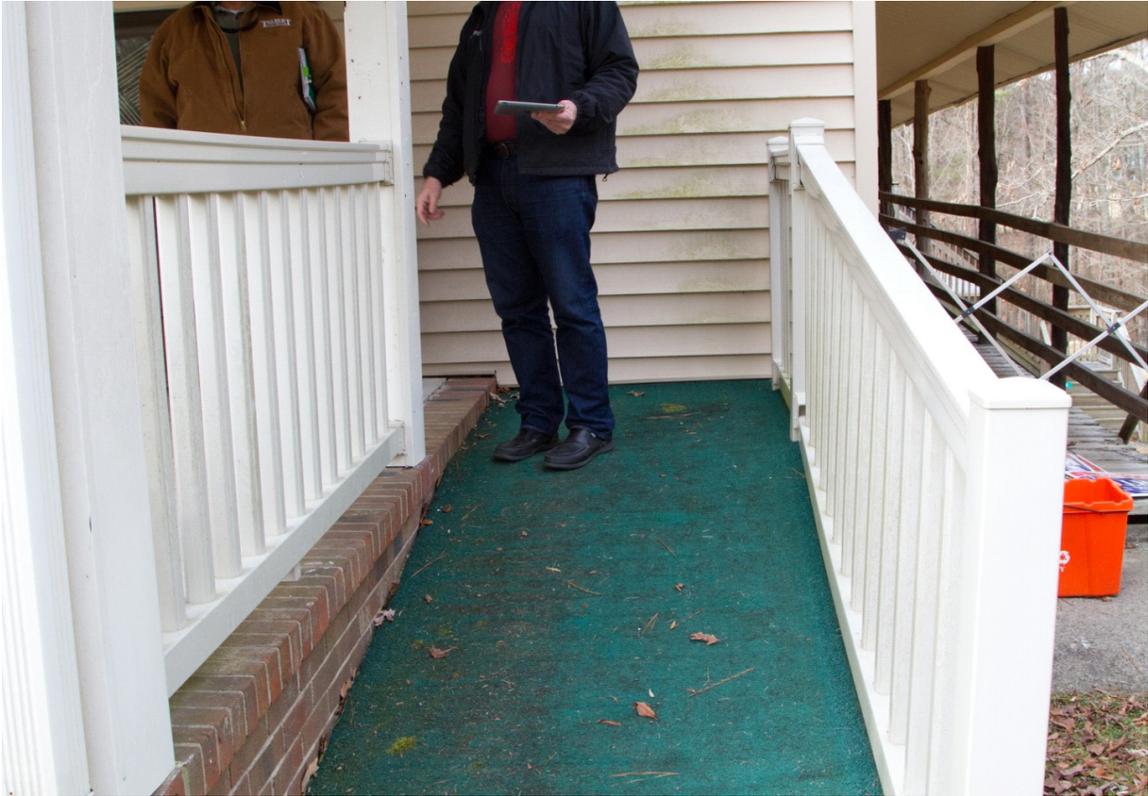
- Add gravel to eliminate the bog at the front of the building
- Front Ramp Railing is very shaky
- Roof Edge & Gutters - damage to the edge of the roof and gutters on the back of the building
- Soffit (vinyl) needs repair at backdoor
- Back Ramp needs to be replaced or removed.

- Regrade back yard to take water away from building
- Kitchen needs to be repainted for HEALTH REASONS
- Updating the Meeting room lighting
- Siding needs washing, no need to replace but it could use some attention to look a lot better
- Fire alarm system will be redone for the entire building and NHIA will need to pay for our part
- Updating the Meeting room walls
- Updating the Meeting room flooring
- Inside bathrooms are in need of updating
- Front shrubbery looking pretty bad, probably should be replaced
- Folding chairs need upgrading
- New pots and pans need upgrading
